**Ellison Park
Area Master
Plans**

Monroe County, New York

BUILDING CONDITION SURVEY

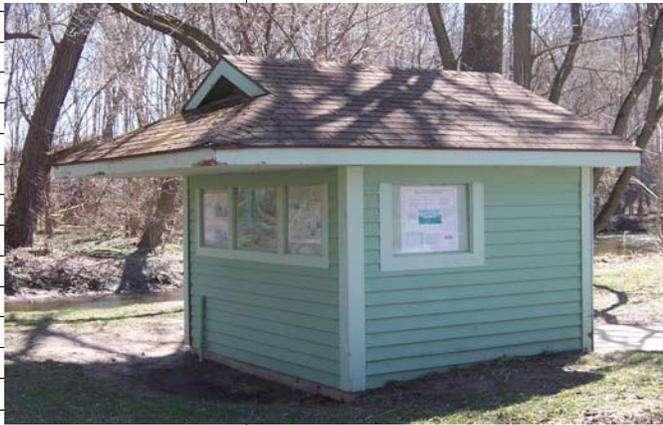
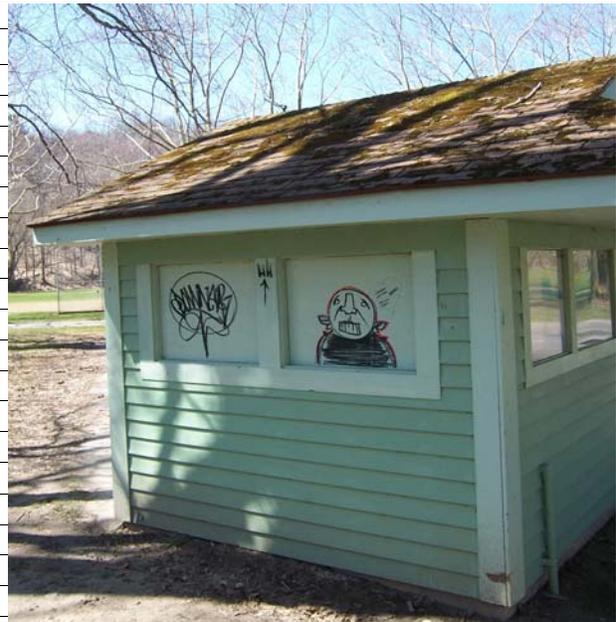
Date	4/15/2008
Park	Ellison Park
Structure	Canoe Launch
Year constructed	1990 +/-
Arch. Significant	NA
No. of stories	1
Sprinklers	NA
Gross SF +/-	85 sf +/-
Plans available	Assumed yes
Exterior wall type	Painted wood clapboard siding, minor repairs and painting needed
Structural system	Wood timber
Found./Floor Slab	Concrete foundation and concrete slab assumed good condition
Roof	Asphalt shingles; fair to good condition, moss is causing premature damage; consider power washing
Soffits / Cornice	Have insect damage on soffit; also has been hit and is damaged for people; requires repair
Interior Finishes	did not view
Plumbing	NA
HVAC	NA
Electrical	Yes
Stairs and Railings	NA
Doors	NA
Windows	NA
Chimneys	NA
Energy Utilization	NA
Handicapped Accessible	Yes, allocated parking spaces, however no paved area at windows (dirt path)
Toilet facilities	NA
General Notes	Graffiti exists, but appears that paint will cover it; foot traffic has created a dirt area at booth access, may become an erosion problem in the future.

Condition Rating	Good

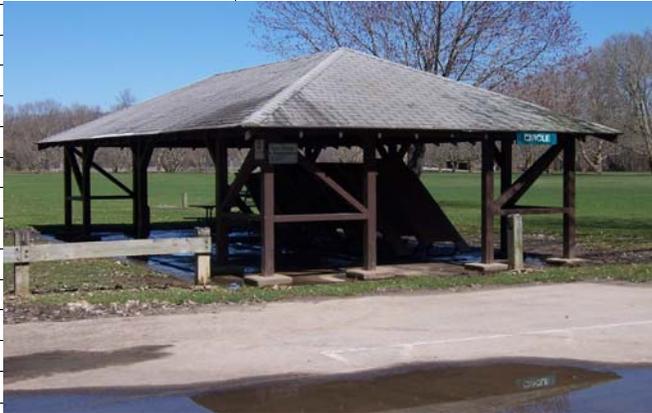
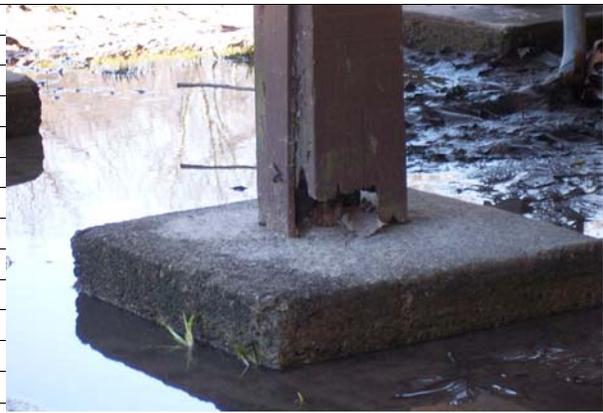
Date	4/15/2008
Park	Ellison Park
Structure	Circle Shelter
Year constructed	1940 - 1960's?
Arch. Significant	NA
No. of stories	1
Sprinklers	NA
Gross SF +/-	648 sf +/- (18' x 36')
Plans available	NA
Exterior wall type	Open Structure, paint is in fair to good condition
Structural system	Heavy Timber / wood roof framing
Found./Floor Slab	Foundation at column bases is above slab / slab has some cracks, perimeter slab slopes toward interior
Roof	Asphalt shingles; poor condition should be replaced
Soffits / Cornice	Okay
Interior Finishes	NA
Plumbing	NA
HVAC	NA
Electrical	NA
Stairs and Railings	NA
Doors	NA
Windows	NA
Chimneys	NA
Energy Utilization	NA
Handicapped Accessible	Yes, allocated parking spaces
Toilet facilities	NA
General Notes	This structure has been subjected to flooding. Slab and base of columns are subject to water, therefore bottom of a few columns are rotted, recommend repair
Condition Rating	Fair; short term repair recommended

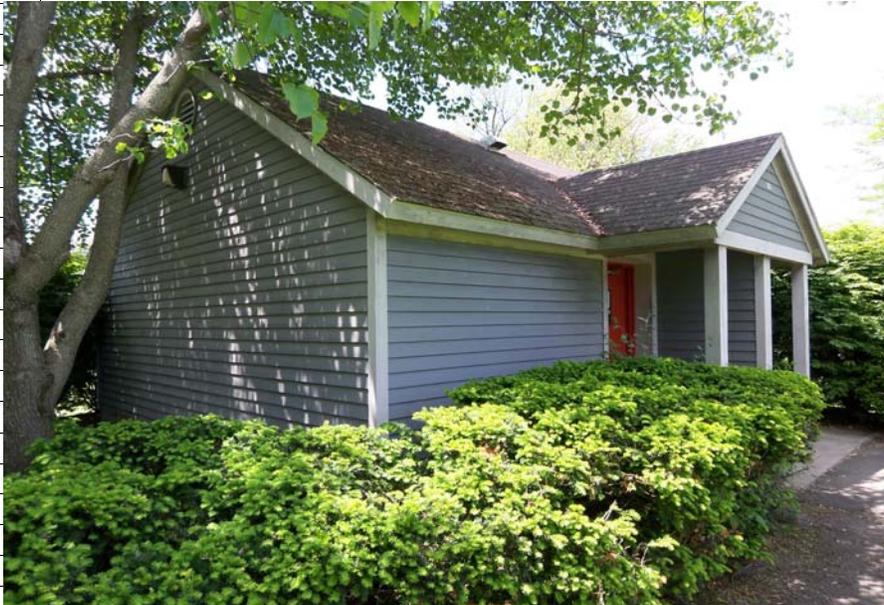
Date	5/28/2008
Park	Ellison Park
Structure	Creekside Toilet Building
Year constructed	1986
Arch. Significant	NA
No. of stories	1
Sprinklers	NA
Gross SF +/-	565 sf +/-
Plans available	Yes
Exterior wall type	Painted clapboard siding; some repair needed; needs painting along with trim
Structural system	Masonry wall with wood frame
Found./Floor Slab	Concrete block foundation assumed, slab on grade
Roof	Asphalt shingles; Poor condition: Shingles should be removed and new installed
Soffits / Cornice	Wood soffit have some damage and require painting; no gutters
Interior Finishes	All finishes are in excellent condition: FRP ceilings, glazed block walls, tile floor
Plumbing	Multiperson sink is showing some pitting in the bowl; Toilets good. Non-automated flush
HVAC	6 toilets women, 2 toilet, 1 trough urinal men
Electrical	Exhaust fans; should be further evaluated for their effectiveness
Stairs and Railings	Good
Doors	NA

Windows	Doors require painting, closers are rusted, should be replaced or painted
Chimneys	NA
Energy Utilization	NA
Handicapped Accessible	9" batt insulation in the roof, 6" in the walls
Toilet facilities	Handicapped stall size is outdated (3'-0" wide), removal of a stall could provide for a larger HC stall
General Notes	yes
	The exterior of the building needs repair. The roof, immediately. Recommend tear off due to moss growth.
Condition Rating	Pruning of adjacent plants could help with premature aging of exterior
	Interior: good to excellent; Exterior: Fair

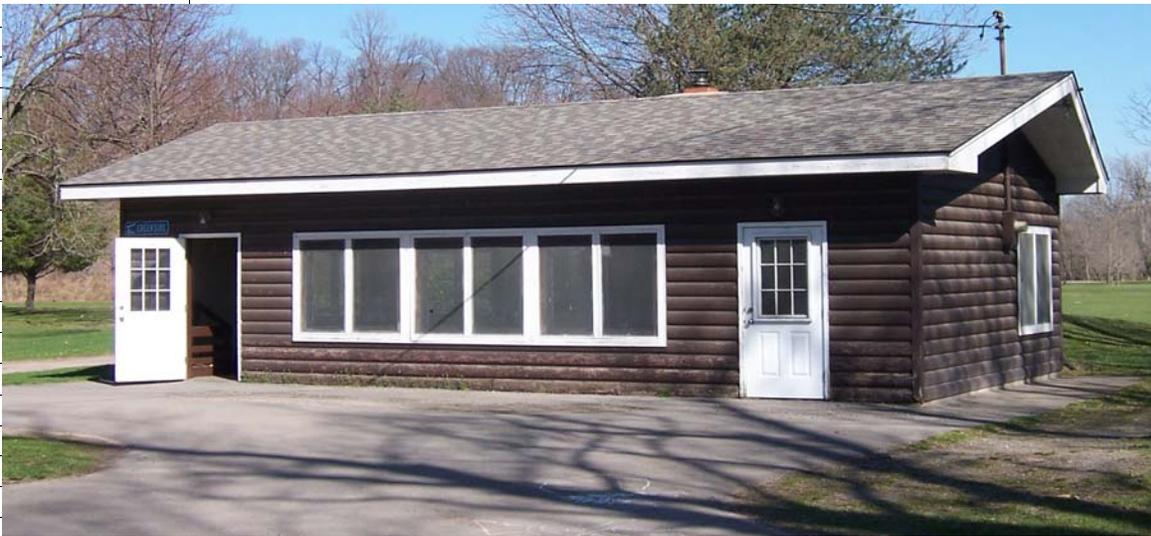
Date	5/28/2008
Park	Ellison Park
Structure	Creekside Pavilion
Year constructed	1940 - 1960's?
Arch. Significant	NA
No. of stories	1
Sprinklers	NA
Gross SF +/-	730 sf +/-
Plans available	NA
Exterior wall type	Wood frame with log siding; paint is in fair condition; repair and repainting needed due to water damage
Structural system	Wood wall and roof framing (not sure if flooding has effect wall construction)
Found./Floor Slab	Slab on grade, in good condition
Roof	Asphalt shingles; Excellent condition (new)
Soffits / Cornice	Wood fascias have some insect damage
Interior Finishes	Painted drywall, good to excellent condition
Plumbing	NA
HVAC	small electrical units, fair to good condition
Electrical	Yes; lighting and electrical range
Stairs and Railings	NA
Doors	Fair to good
Windows	Good
Chimneys	Masonry has many cracks that appear to be caused by settling of the foundation on the exterior, and undersized lintel on the interior; masonry could use a good cleaning

Energy Utilization	NA
Handicapped Accessible	Yes, allocated parking spaces
Toilet facilities	NA
General Notes	This structure has been subjected to flooding. Wood siding could use replacement at the lower few boards and repainting
Condition Rating	Good ; recommend repairing the masonry work

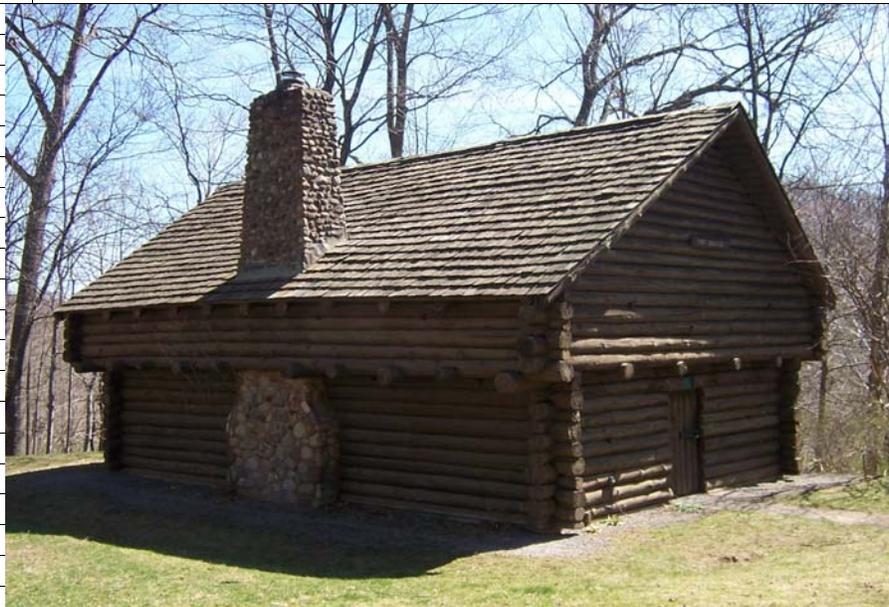
Date	5/28/2008
Park	Ellison Park
Structure	Fort Schuyler - Trading Post
Year constructed	1938
Arch. Significant	Recreated Fort (a pre-existing building approximate location, dated 1721+/-)
No. of stories	1; cathedral ceiling
Sprinklers	NA
Gross SF +/-	750 sf +/-
Plans available	NA
Exterior wall type	Log wall construction, has some damage from: Dry rot, insects and graffiti carvings
Structural system	Heavy timber
Found./Floor Slab	Stone floor, excellent condition
Roof	Cedar shake shingles; good condition
Soffits / Cornice	The rake edge trim has some damage, some birds are nesting between siding and soffit
Interior Finishes	Logs are in good condition; some insect damage, but appears not to effect structural integrity
Plumbing	NA
HVAC	NA
Electrical	Interior lights illuminate structure in a sensitive way, low light level; hardwired smoke detectors exist.
Stairs and Railings	NA
Doors	Doors has some wear, operationally good

Windows	NA
Chimneys	Working wood fireplace, limited use. Stonework is in good condition
Energy Utilization	NA
Handicapped Accessible	Door width is okay, hardware is not accessible (with assistance, yes)
Toilet facilities	NA
General Notes	The building was refurbished in 1986; Repairs to the siding should occur soon, especially on the dry rot, and bird nests.
Condition Rating	Good

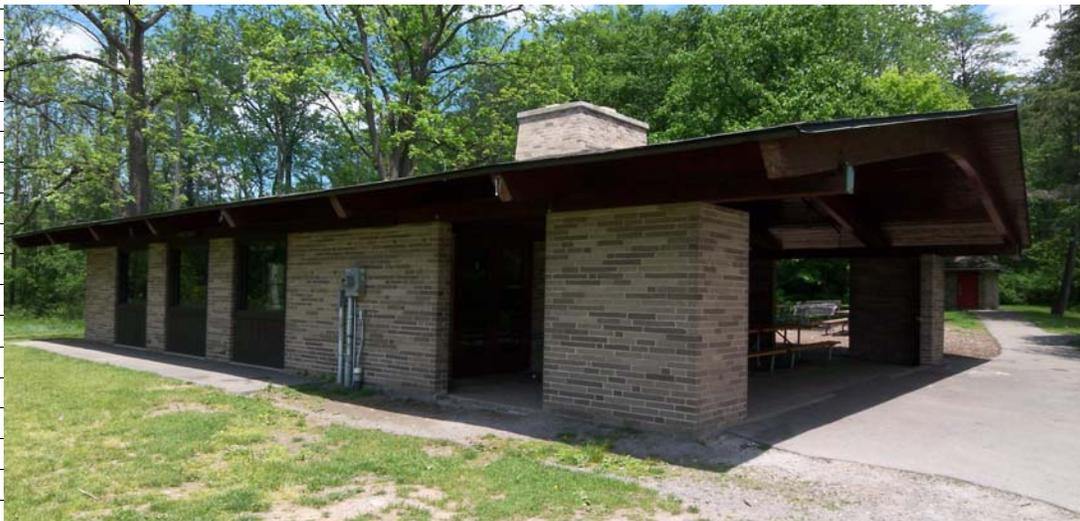
Date	4/17/2008
Park	Ellison Park
Structure	Hazelwood Lodge
Year constructed	1970
Arch. Significant	NA
No. of stories	1
Sprinklers	NA
Gross SF +/-	1,600 sf (includes 410 sf covered porch)
Plans available	NA
Exterior wall type	Brick masonry walls
Structural system	Glue-lam roof beams; wood ceiling (cathedral)
Found./Floor Slab	Concrete slab on grade; at porch some erosion has occurred creating large cracks; interior slightly pitted
Roof	Asphalt shingles; Good to excellent condition
Soffits / Cornice	Wood soffits in good condition, refinishing required in near future; no gutters or down spouts
Interior Finishes	Brick and stained wood. Stained wood could use a little refurbishing
Plumbing	NA
HVAC	Wood burning stove, good condition (2 years old)
Electrical	Electrical cook top; incandescent lights through out
Stairs and Railings	NA
Doors	Double metal leaves 2'-6" wide each
Windows	Metal single pane sliders, good condition

Chimneys	Masonry repointing needed: exterior fireplace has been blocked in
Energy Utilization	Building is not insulated
Handicapped Accessible	Allocated parking spaces; Doors are accessible when both leaves are open; hardware is knob type or missing
Toilet facilities	Adjacent building, see Hazelwood Toilet Survey
General Notes	The brick has weathered well. Some minor repair/repointing needed on chimney on the interior, also masonry cleaning at same location; regrading at eastern corner could help with redirecting water that is effecting the sidewalk and could eventually be detrimental to the corner of the structure.
	Perimeter asphalt sidewalk should be extended at the southern corner where there is a lot of traffic and has eradicated the lawn; horizontal exterior beams need refinishing
Condition Rating	Good

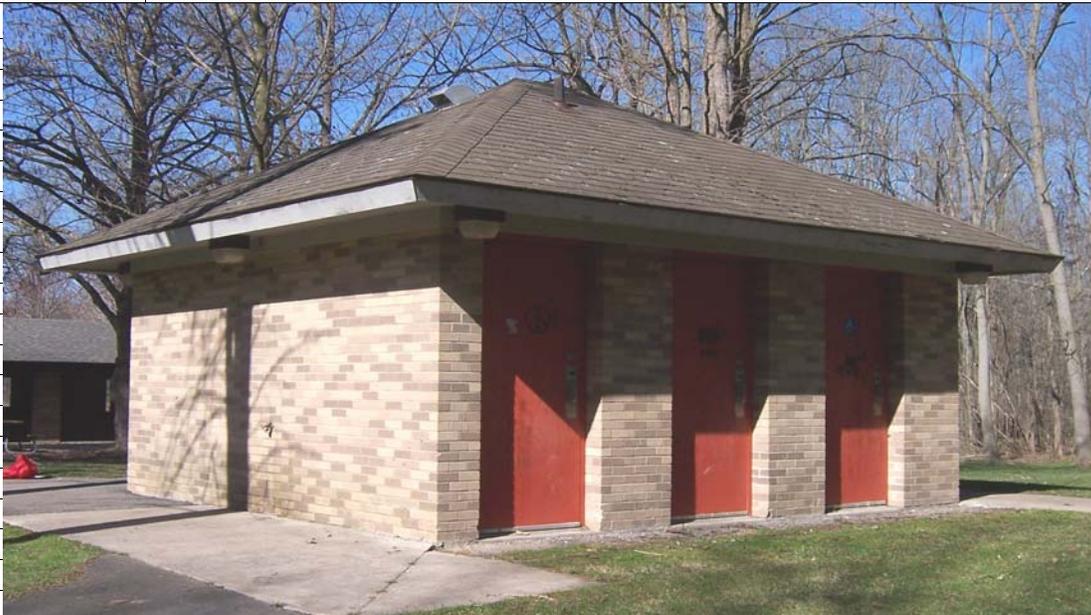
Date	4/17/2008
Park	Ellison Park
Structure	Hazelwood Toilet Building
Year constructed	1980's
Arch. Significant	NA
No. of stories	1
Sprinklers	NA
Gross SF +/-	300 sf
Plans available	Yes
Exterior wall type	Brick exterior face, painted block interior
Structural system	Masonry with wood framed roof
Found./Floor Slab	Concrete block foundation, slab on grade
Roof	Asphalt shingles; Fair to good condition
Soffits / Cornice	Wood soffit needs painting, no gutters
Interior Finishes	All finishes are in excellent condition: FRP ceilings, glazed block walls, tile floor
Plumbing	Sinks and toilets are good. Non-automated flush
HVAC	Exhaust fans only
Electrical	Lighting in god condition
Stairs and Railings	NA
Doors	Doors require painting, back side doors are subjected to graffiti
Windows	NA
Chimneys	NA
Energy Utilization	9" batt insulation in roof; 2" rigid insulation in wall
Handicapped Accessible	Handicapped stall size is undersized compared to today's standards (5'-0" x 5'-6" w/ sink)

Toilet facilities	6 individual toilet rooms with sinks
General Notes	Sidewalk should be extended to be in front of three doors on the back side (presently there is none)
Condition Rating	Interior: good to excellent; Exterior: Good

Hazelwood Toilet Building	Repair damaged fascias, repaint doors due to graffiti, extend sidewalk in front of three doors	\$ 3,200
Island Shelter	New concrete slab at higher elevation, tear off roof and replace	\$ 20,000
Old Meadow Shelter	Replace slab, smooth out walkway to shelter for HC access, minor painting	\$ 27,000
Orchard Grove Shelter	Tear off and replace roof, overall painting, repair columns fill in or grind down slab at cracks where a tripping hazard	\$ 20,000
Pavilion Lodge	Stone chimney repointing, masonry chimney rebuild and repointing, exterior painting, replace basement stairs, replace exterior stone stair and railing, replace gutters and downspouts, see note 3	\$ 65,000
Roadside Shelter	New concrete slab at higher elevation, repair columns that are rotted tear off and replace roof, general painting	\$ 23,000
South Lodge	repair fascias and soffits, replace gutters and downspouts	\$ 10,000

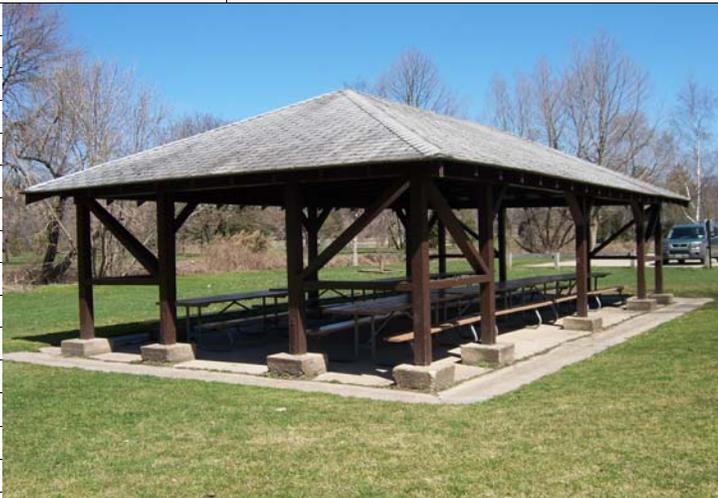
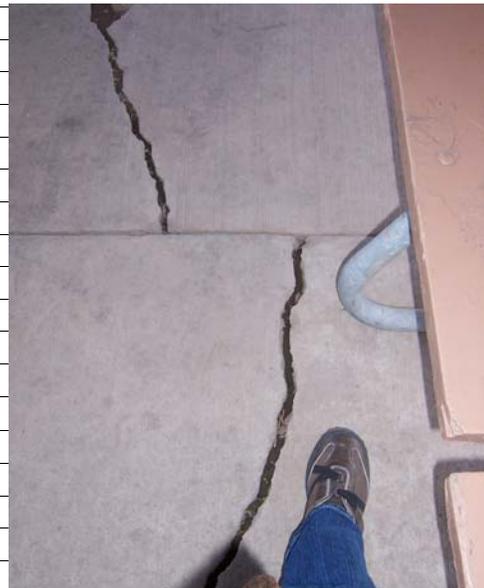
Date	4/15/2008
Park	Ellison Park
Structure	Island Shelter
Year constructed	1940 - 1960's?
Arch. Significant	NA
No. of stories	1
Sprinklers	NA
Gross SF +/-	
Plans available	NA
Exterior wall type	Open Structure, paint is in fair to good condition
Structural system	Heavy Timber / wood roof framing
Found./Floor Slab	Foundation at column bases is above slab / slab has large cracks, perimeter slab slopes toward interior
Roof	Asphalt shingles; poor condition should be replaced
Soffits / Cornice	Okay
Interior Finishes	NA
Plumbing	NA
HVAC	NA
Electrical	NA
Stairs and Railings	NA
Doors	NA
Windows	NA
Chimneys	NA
Energy Utilization	NA
Handicapped Accessible	Yes, allocated parking spaces
Toilet facilities	NA
General Notes	This structure has been subjected to flooding. Slab cracks are significant, and grade is higher than slab
Condition Rating	Fair; short term repair recommended, specifically replacing the slab to be level with the footing tops.

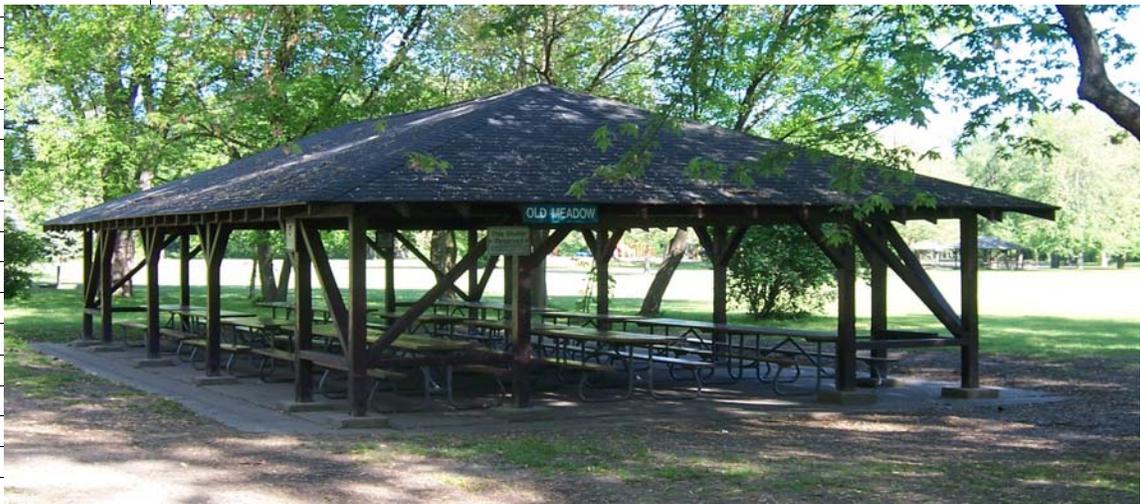
Date	5/28/2008
Park	Ellison Park
Structure	Old Meadow Shelter
Year constructed	1940 - 1960's?
Arch. Significant	NA
No. of stories	1
Sprinklers	NA
Gross SF +/-	1152 sf +/- (24' x 48')
Plans available	NA
Exterior wall type	Open Structure, paint is in fair to good condition: minor painting required
Structural system	Heavy Timber / wood roof framing - a few columns exhibited rot at the bottom near footing
Found./Floor Slab	Foundation at column bases is above slab / slab has cracks, perimeter slab slopes toward interior
Roof	Asphalt shingles fair to good
Soffits / Cornice	Fair to good
Interior Finishes	NA
Plumbing	NA
HVAC	NA
Electrical	NA
Stairs and Railings	NA
Doors	NA
Windows	NA
Chimneys	NA
Energy Utilization	NA
Handicapped Accessible	Allocated parking spaces, however the distance is greater than any other shelter, and the pathway is very uneven, and varies in materials
Toilet facilities	NA
General Notes	This structure has been subjected to flooding. Has slab cracks, and grade is higher than slab

Condition Rating	Good
	It is our assumption that this is a replacement slab due to the lesser clearance at beams (7'-3") and therefore, in the future a new slab could be a few inches higher.

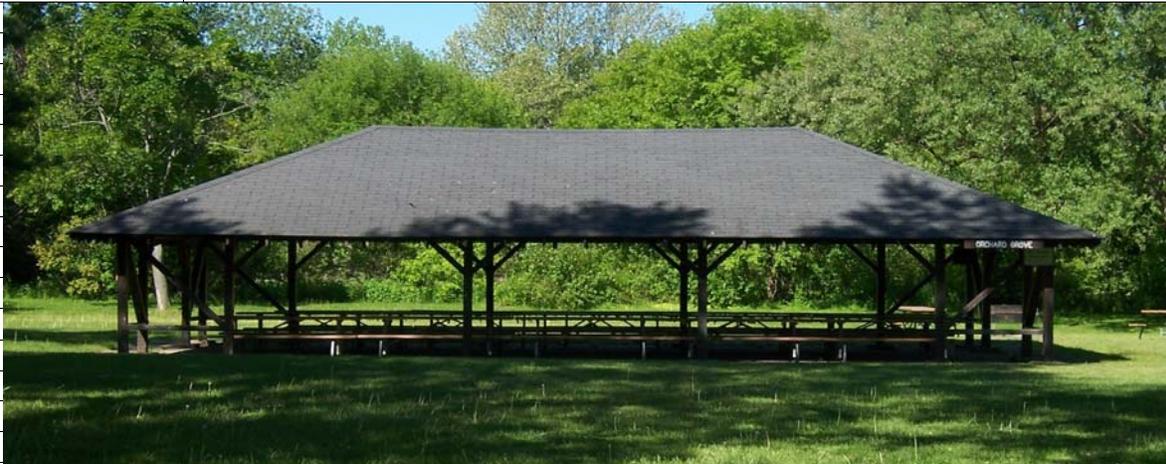
Date	5/28/2008
Park	Ellison Park
Structure	Orchard Grove
Year constructed	1940 - 1960's?
Arch. Significant	NA
No. of stories	1
Sprinklers	NA
Gross SF +/-	1152 sf +/- (24' x 48')
Plans available	NA
Exterior wall type	Open Structure, paint is in poor condition; overall painting required
Structural system	Heavy Timber / wood roof framing - a few columns exhibited rot at the bottom near footing
Found./Floor Slab	Foundation at column bases is above slab / slab has large cracks, perimeter slab slopes toward interior
Roof	Asphalt shingles; poor to fair condition should be replaced
Soffits / Cornice	Fair; need painting, wood appears to be okay
Interior Finishes	NA
Plumbing	NA
HVAC	NA
Electrical	NA
Stairs and Railings	NA
Doors	NA
Windows	NA
Chimneys	NA
Energy Utilization	NA
Handicapped Accessible	Yes, allocated parking spaces
Toilet facilities	NA
General Notes	This structure has been subjected to flooding. Has slab cracks, and grade is higher than slab

Condition Rating	Fair; recommend replacing roof and over all painting It is our assumption that this is a replacement slab due to the lesser clearance at beams (7'-1") and therefore, putting a slab at a higher elevation could not occur.

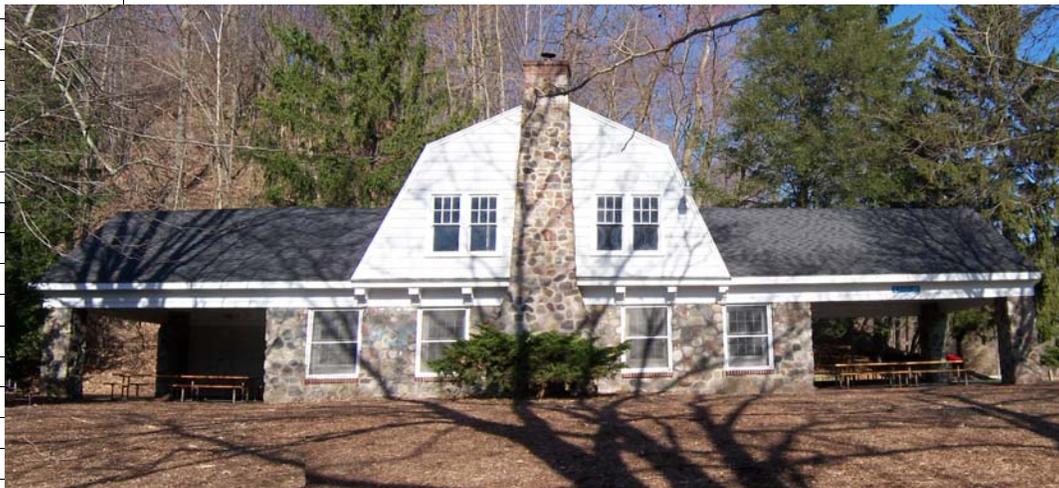
Date	5/28/2008
Park	Ellison Park
Structure	Pavilion Lodge
Year constructed	1920's
Arch. Significant	Building was an original structure at parks inception
No. of stories	2 plus basement
Sprinklers	NA
Gross SF +/-	? sf +/-
Plans available	NA
Exterior wall type	Painted shingle siding; needs painting; Stone work: some has been repaired other areas need repair
Structural system	Wood frame construction
Found./Floor Slab	Stone Foundation
Roof	Asphalt shingles; Good to excellent condition
Soffits / Cornice	Wood fascias have some insect damage, gutter and downspout repair and replacement needed
Interior Finishes	Painted drywall walls and clg, good condition; Varying floor tiles: quarry tile and vinyl tiles fair condition
Plumbing	Older kitchen sink and toilet facilities; grinder pump occasionally has problems
HVAC	Wood burning stove, good condition (2 years old)
Electrical	Fluorescent lights and electrical range; panel is at capacity; exterior security lights, incandescent at porches

Stairs and Railings	Stairs to basement are dilapidated and need replacement, stairs upstairs are good, neither used by public
Doors	Fair to good, some original or in keeping with building style
Windows	Original, good painted single pane
Chimneys	Masonry is in poor condition at the top and needs to be rebuilt, and repointed in other areas Flashing has been used to cover problem areas
Energy Utilization	Building is not insulated
Handicapped Accessible	Allocated parking spaces: route up is porch is acceptable, but ramp up to door is concrete but not to code
Toilet facilities	Yes, not handicapped accessible, required full gutting and reconfiguration
General Notes	Stairs and railing from parking need to be removed and replaced; gutters and downspouts need replacement on the back side; Basement stairs need replacement; paint exterior; Upstairs is not used, and shows signs of a fire that occurred in the 1970's, repair work was done There were water issues on the back side, but seem to be corrected, concrete slab installed may have damaged subfloor (not observed)

Condition Rating	Fair to Good

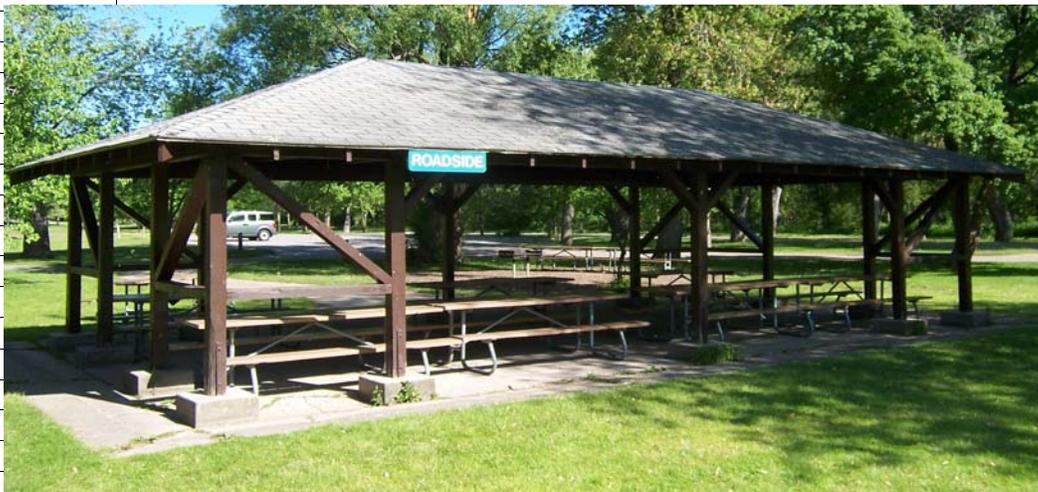
Date	5/28/2008
Park	Ellison Park
Structure	Roadside Shelter
Year constructed	1940 - 1960's?
Arch. Significant	NA
No. of stories	1
Sprinklers	NA
Gross SF +/-	648 sf +/- (18' x 36')
Plans available	NA
Exterior wall type	Open Structure, paint is in fair condition; repainting needed
Structural system	Heavy Timber / wood roof framing - a few columns exhibited rot at the bottom near footing
Found./Floor Slab	Foundation at column bases is above slab / slab has large cracks, perimeter slab slopes toward interior
Roof	Asphalt shingles; poor to fair condition should be replaced
Soffits / Cornice	Fair; need painting, wood appears to be okay
Interior Finishes	NA
Plumbing	NA
HVAC	NA
Electrical	NA
Stairs and Railings	NA
Doors	NA
Windows	NA
Chimneys	NA
Energy Utilization	NA
Handicapped Accessible	Yes, allocated parking spaces
Toilet facilities	NA
General Notes	Undetermined that this structure has been subjected to flooding. Has the slab cracks have begun to be a tripping hazard

Condition Rating	Fair; recommend replacing roof

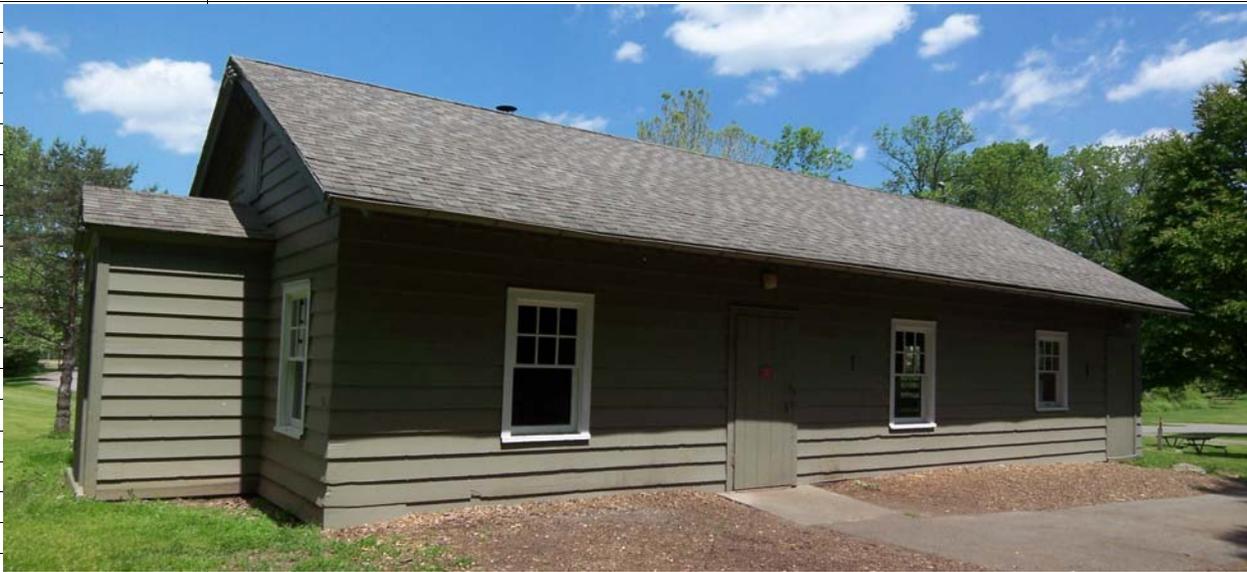
Date	5/28/2008
Park	Ellison Park
Structure	South Lodge
Year constructed	1950's
Arch. Significant	NA
No. of stories	1
Sprinklers	NA
Gross SF +/-	800 sf +/-
Plans available	NA
Exterior wall type	Painted clapboard siding; good condition
Structural system	Wood frame construction
Found./Floor Slab	Stone Foundation
Roof	Asphalt shingles; Good to excellent condition
Soffits / Cornice	Wood soffit have some damage, gutter and downspout replacement needed
Interior Finishes	stained bead board, walls and ceiling
Plumbing	assume one sink
HVAC	Wood burning stove, good condition
Electrical	Older fluorescent lights and electrical range
Stairs and Railings	NA
Doors	All doors but one have been closed off. Main entry okay
Windows	Original, good painted single pane
Chimneys	Masonry is in good condition, repointing has occurred
Energy Utilization	Building is not insulated
Handicapped Accessible	Allocated parking spaces:
Toilet facilities	NA

General Notes	This structure appears not to have issues with flooding
Condition Rating	Good

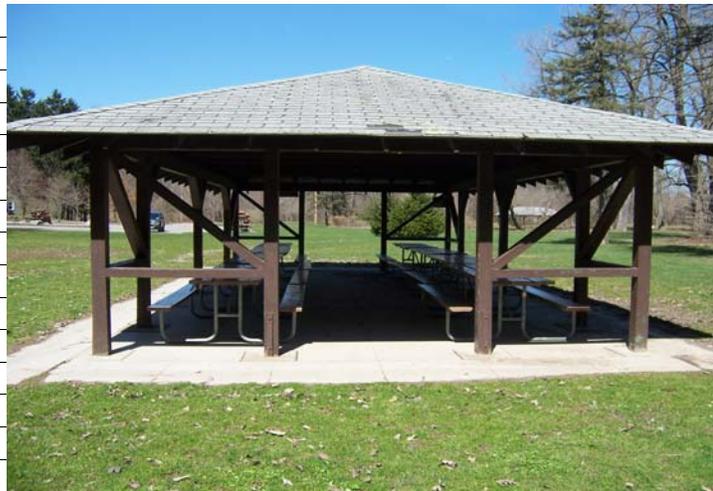
Date	4/15/2008
Park	Ellison Park
Structure	Spruce Shelter
Year constructed	1940 - 1960's?
Arch. Significant	NA
No. of stories	1
Sprinklers	NA
Gross SF +/-	648 sf +/- (18' x 36')
Plans available	NA
Exterior wall type	Open Structure, paint is in fair to good condition*
Structural system	Heavy Timber / wood roof framing
Found./Floor Slab	New floor slab is flush with footer tops and in excellent condition
Roof	Asphalt shingles; poor condition should be replaced
Soffits / Cornice	Okay
Interior Finishes	NA
Plumbing	NA
HVAC	NA
Electrical	NA
Stairs and Railings	NA
Doors	NA
Windows	NA
Chimneys	NA
Energy Utilization	NA
Handicapped Accessible	Yes, allocated parking spaces
Toilet facilities	NA

Condition Rating fair, slab excellent

Spruce Shelter	Tear off and replace roof	\$ 4,000
Sycamore Shelter	Demolish existing shelter, provide new stock shelter, provide raised work area and new slab	\$ 80,000
continued

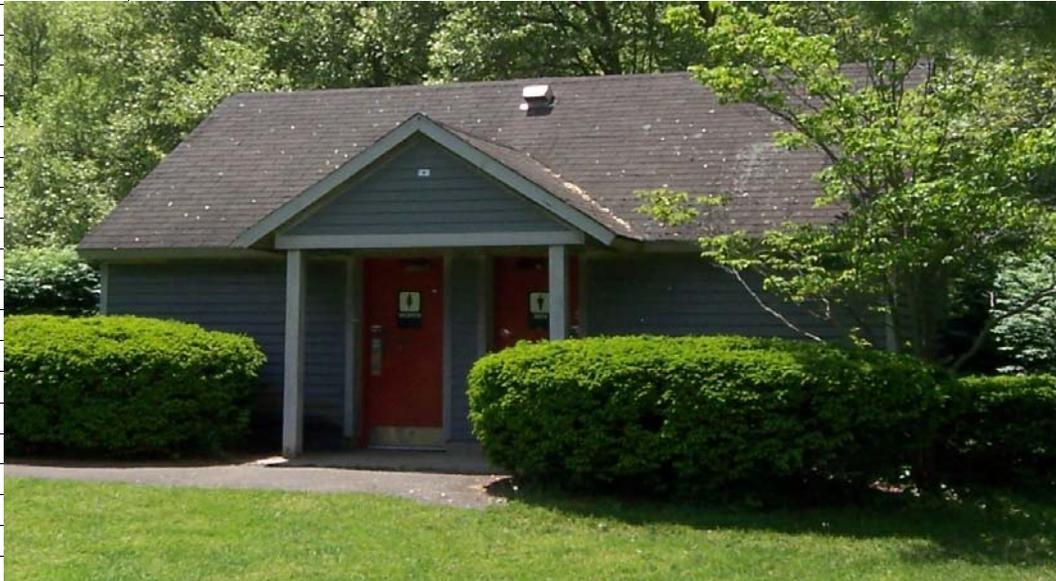
Date	5/28/2008
Park	Ellison Park
Structure	Sycamore Toilet Building
Year constructed	1986
Arch. Significant	NA
No. of stories	1
Sprinklers	NA
Gross SF +/-	565 sf +/-
Plans available	Yes
Exterior wall type	Painted clapboard siding; some repair needed; needs painting along with trim
Structural system	Masonry wall with wood frame
Found./Floor Slab	Concrete block foundation assumed, slab on grade
Roof	Asphalt shingles; Poor condition: Shingles should be removed and new installed
Soffits / Cornice	Wood soffit have some damage and require painting; no gutters
Interior Finishes	All finishes are in excellent condition: FRP ceilings, glazed block walls, tile floor
Plumbing	Multiperson sink is showing some pitting in the bowl; Toilets good. Non-automated flush 6 toilets women, 2 toilet, 1 trough urinal men
HVAC	Exhaust fans; should be further evaluated for their effectiveness
Electrical	Good
Stairs and Railings	NA
Doors	Doors require painting, closers are rusted, should be replaced or painted

Windows	NA
Chimneys	NA
Energy Utilization	9" batt insulation in the roof, 6" in the walls
Handicapped Accessible	Handicapped stall size is outdated (3'-0" wide), removal of a stall could provide for a larger HC stall
Toilet facilities	yes
General Notes	The exterior of the building needs repair. The roof, immediately. One mirror requires replacement
Condition Rating	Interior: good to excellent; Exterior: Fair

Sycamore Toilet	Tear off and replace roof, complete painting for entire exterior exhaust fan repair, modify handicapped stall to make code compliant	\$ 20,000
Notes:		
1. Costs are base on 2008 pricing. Assumed publicly bid at prevailing wage rates. No architectural or engineering fees are included.		
2. A prefab unit most likely will be more cost effective over site built due to the structural engineering required to design a field built shelter. The manufacturer indicated that the materials would be 40 % less (-\$9,600) if the roof is gabled in lieu of a hipped roof.		
3. At the time of this study, the park was going to be updating the toilets in Pavilion Lodge to make them handicapped accessible. Therefore, no cost has been included for this work. Even though the ramp into the main door is not to code, we have not allocated funding to make a code compliant ramp at this time.
